RESERVE FUND REPORT

**RIVER PARK GLEN
21 MACDONALD DRIVE
FORT MCMURRAY, ALBERTA
CANADA**

CONDOMINIUM CORPORATION #112235

**RE: Reserve Fund Report
River Park Glen
21 MacDonald Drive
Fort McMurray, Alberta
Condominium Corporation #1122235**

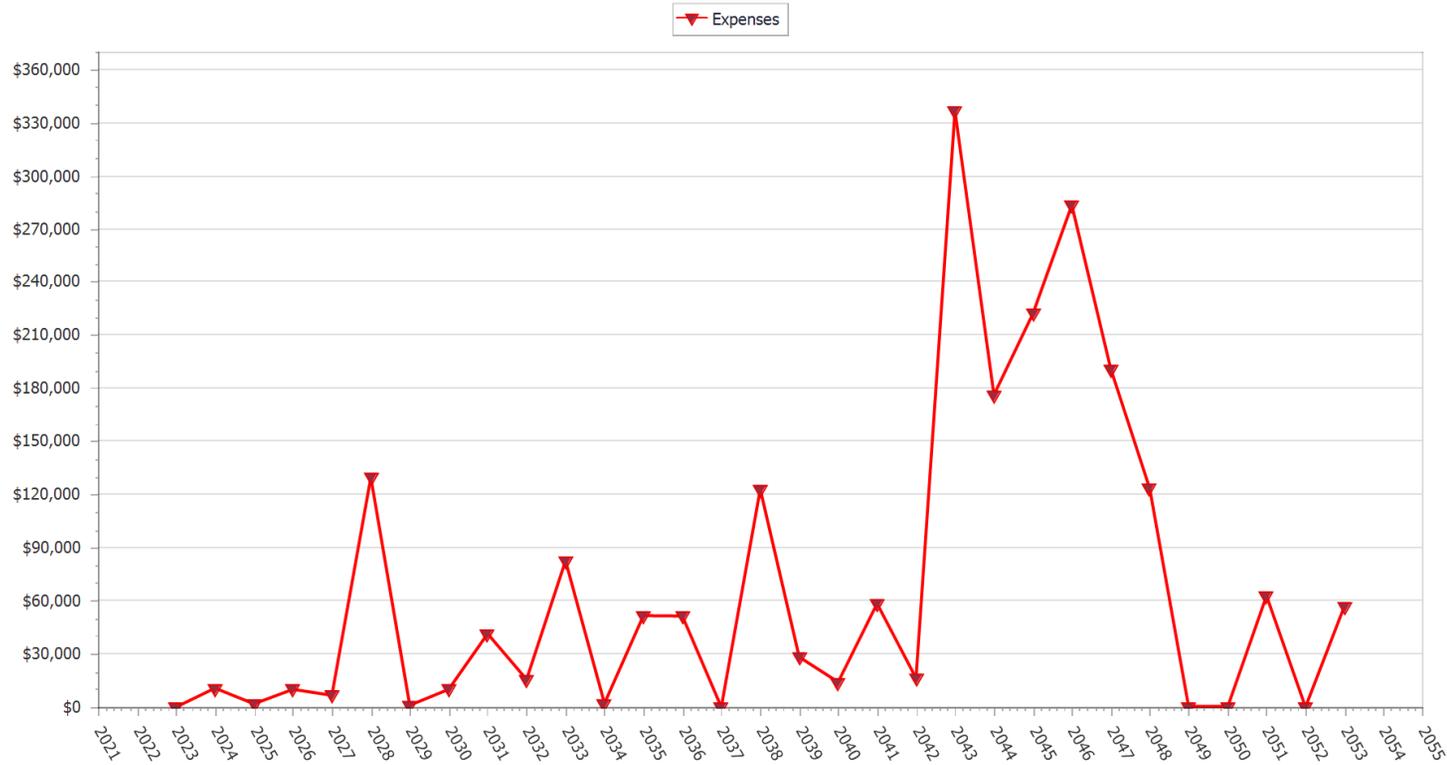
Funding Horizon Chart - Model Amenity Final
River Park Glen - Amenity - 1122235

Stabilized Long Term Inflation Rate - 3.50%
Stabilized Long Term Interest Rate - 3.00%
First Five Year Interest Rate - 4.80%

Minimum Closing Balance in Year 30 :(\$2,106,441)

Total Cash Outlay: \$0

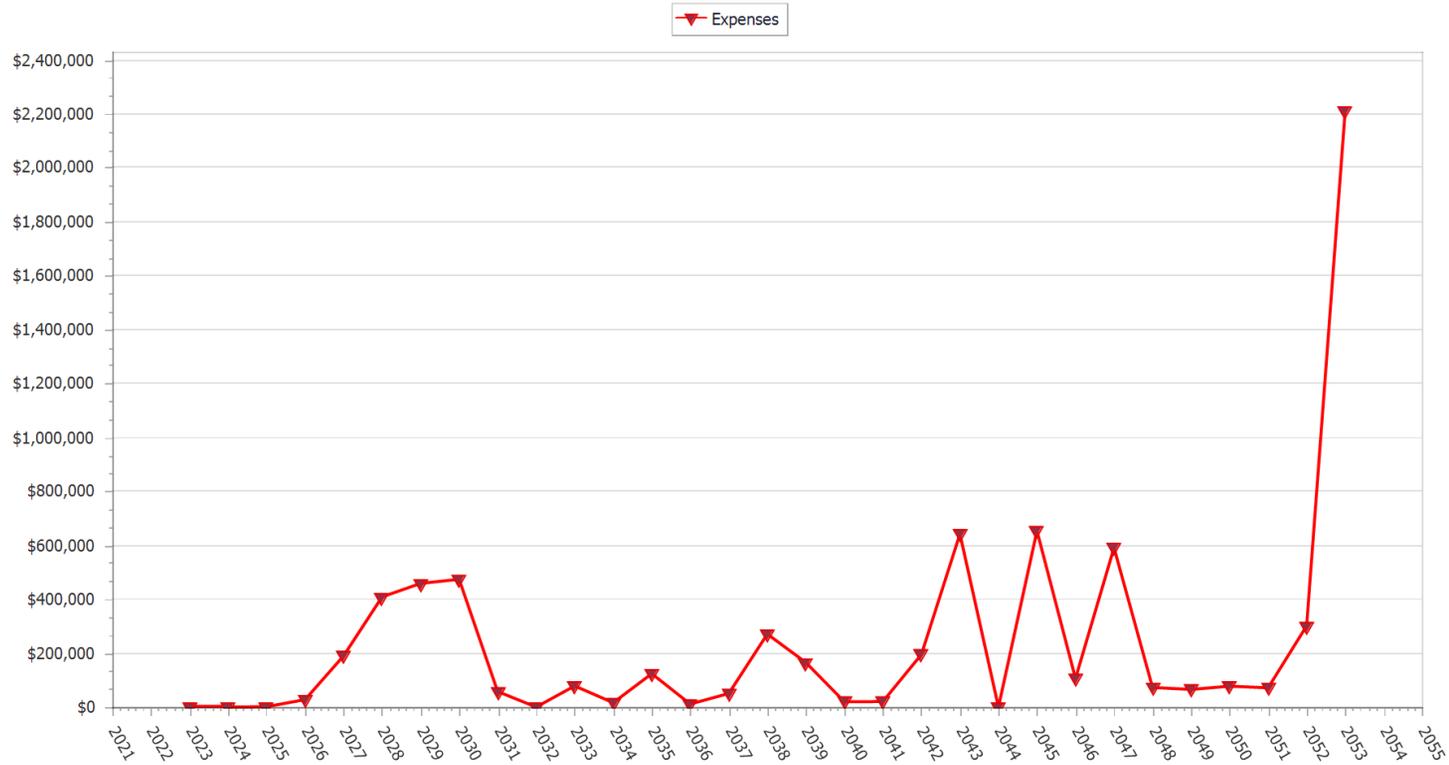
Funding Horizon Chart - Model High Rise C Final
River Park Glen - High Rise 2 (Zone C) - 1122235

Stabilized Long Term Inflation Rate - 3.50%
Stabilized Long Term Interest Rate - 3.00%
First Five Year Interest Rate - 4.80%

Minimum Closing Balance in Year 30 :(\$7,358,643)

Total Cash Outlay: \$0

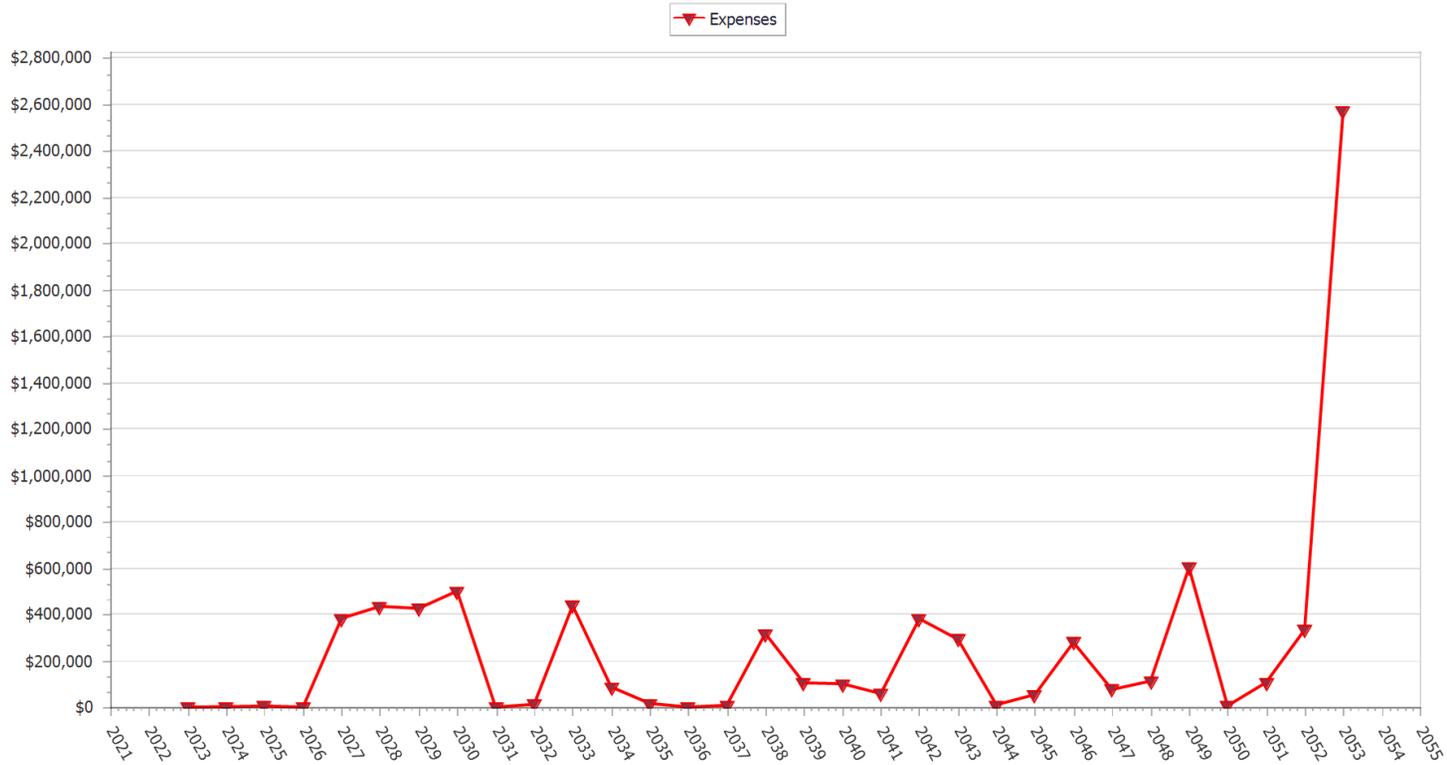
Funding Horizon Chart - Model High Rise D Final
River Park Glen - High Rise 1 (Zone D) - 1122235

Stabilized Long Term Inflation Rate - 3.50%
Stabilized Long Term Interest Rate - 3.00%
First Five Year Interest Rate - 4.80%

Minimum Closing Balance in Year 30 :(\$7,714,188)

Total Cash Outlay: \$0

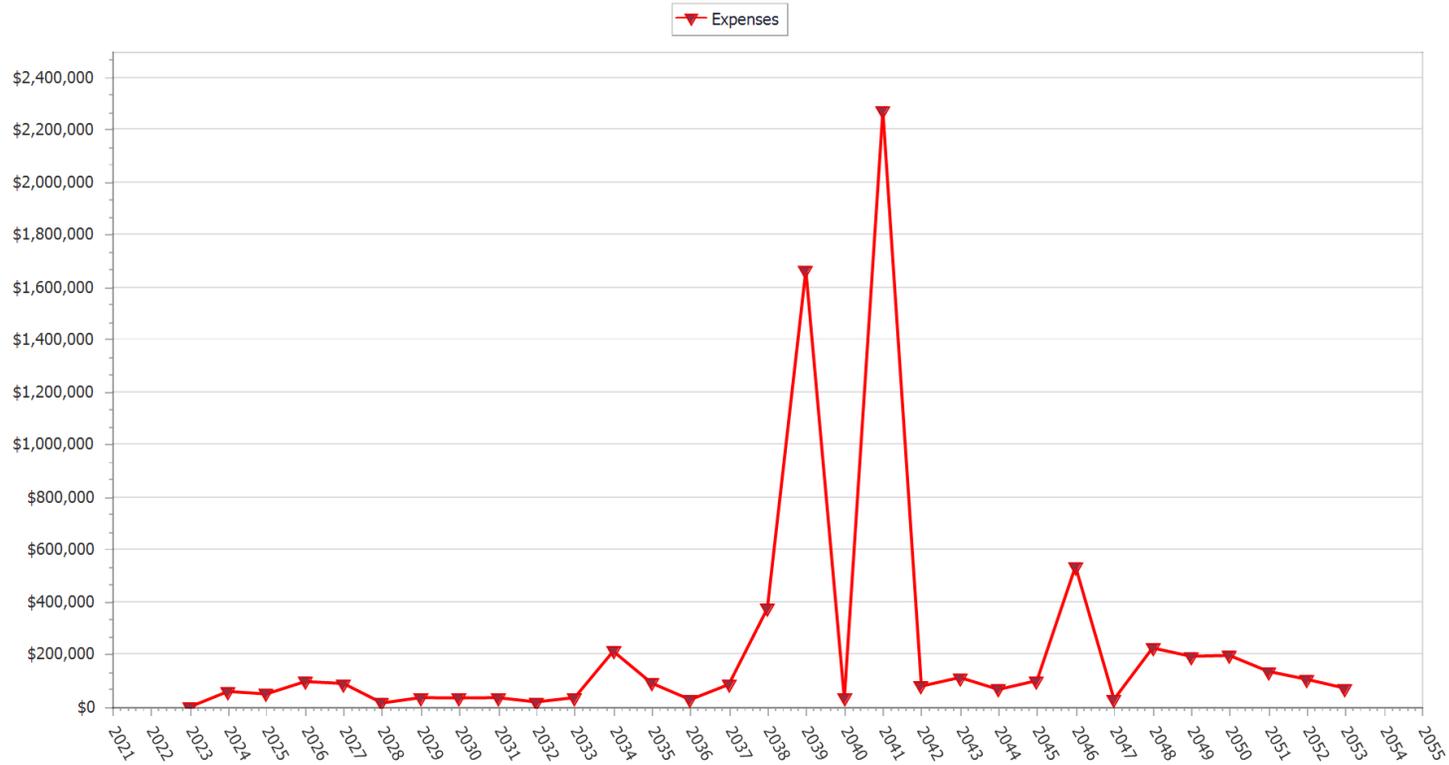
Funding Horizon Chart - Model Low Rise B Final
River Park Glen - Low Rise (Zone B) - 1122235

Stabilized Long Term Inflation Rate - 3.50%
Stabilized Long Term Interest Rate - 3.00%
First Five Year Interest Rate - 4.80%

Minimum Closing Balance in Year 30 :(\$7,085,757)

Total Cash Outlay: \$0

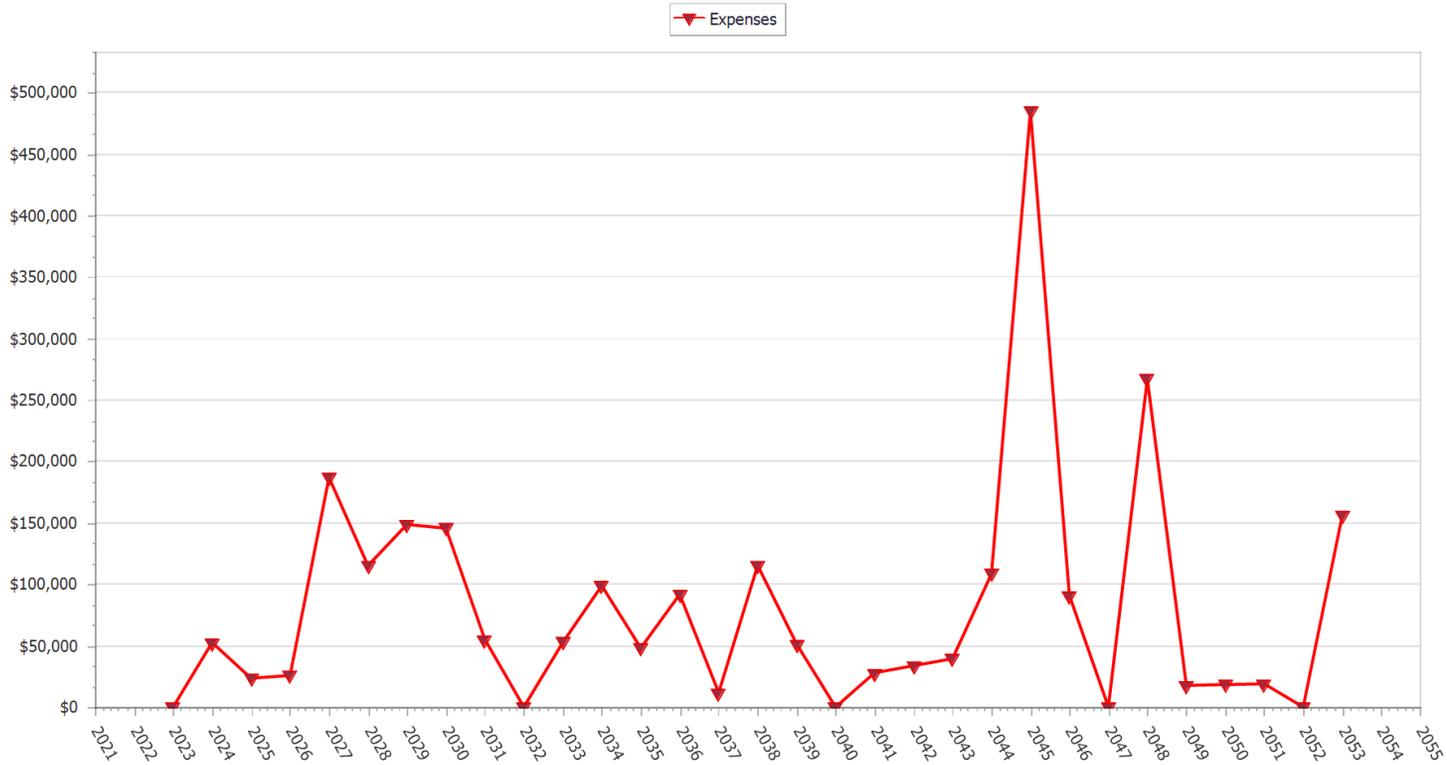
Funding Horizon Chart - Model Site Improvements Final
River Park Glen - Site Improvements - 1122235

Stabilized Long Term Inflation Rate - 3.50%
Stabilized Long Term Interest Rate - 3.00%
First Five Year Interest Rate - 4.80%

Minimum Closing Balance in Year 30 :(\$2,485,598)

Total Cash Outlay: \$0

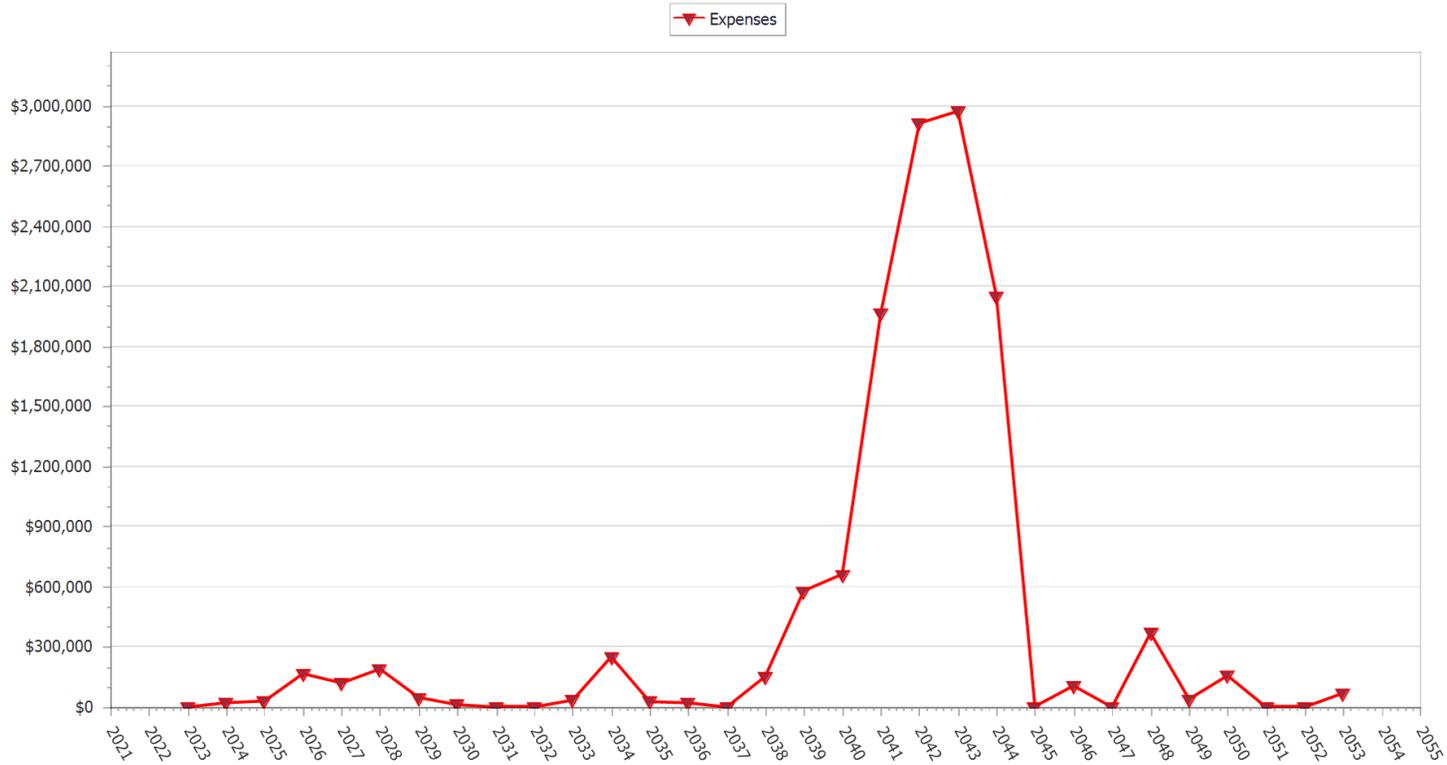
Funding Horizon Chart - Model Upper & Lower Mews Final
River Park Glen - Upper & Lower Mews - 1122235

Stabilized Long Term Inflation Rate - 3.50%
Stabilized Long Term Interest Rate - 3.00%
First Five Year Interest Rate - 4.80%

Minimum Closing Balance in Year 30 :(\$12,961,662)
Total Cash Outlay: \$0
Total Expenditures: \$12,961,662

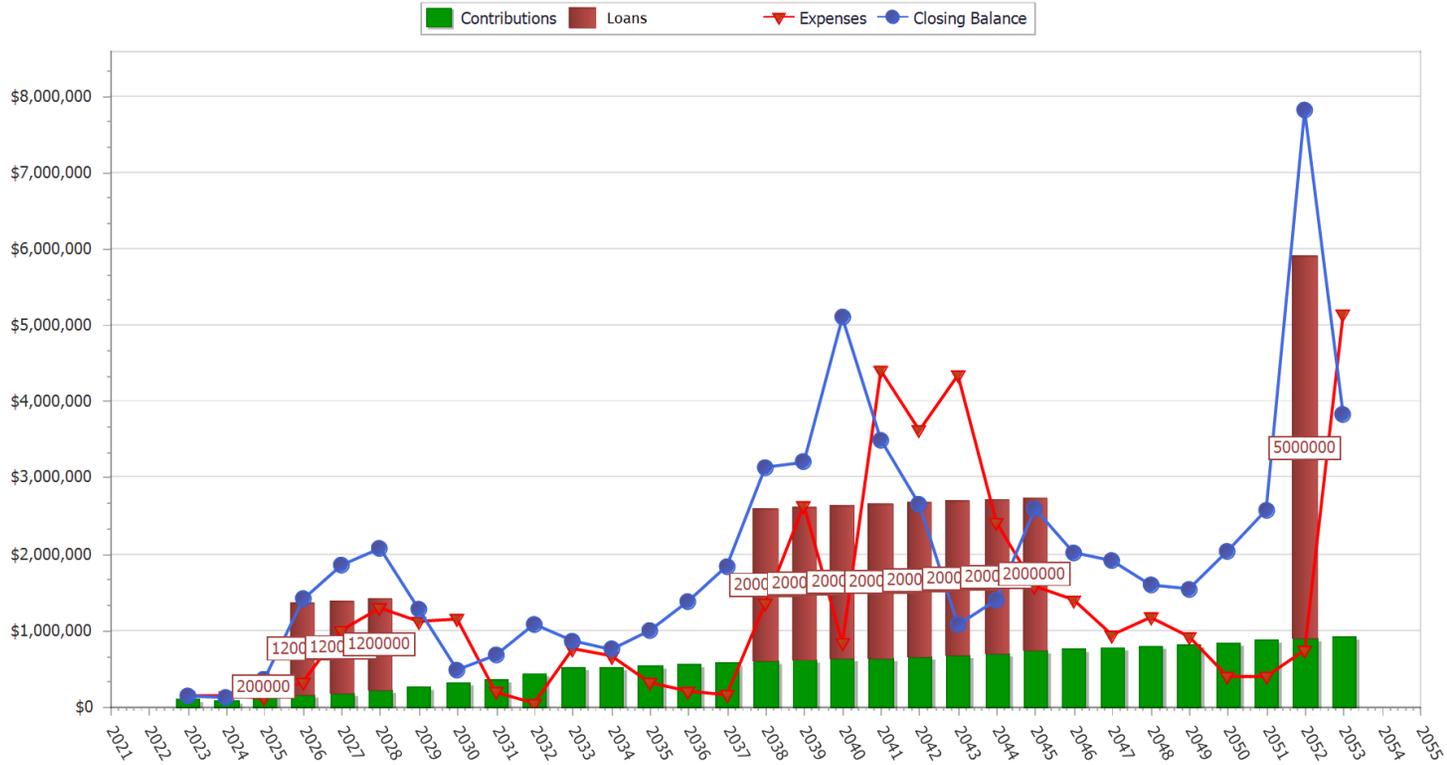
Funding Horizon Chart - Model 30 Years Final
 River Park Glen - Buildings Summary - 1122235

Stabilized Long Term Inflation Rate - 3.50%
 Stabilized Long Term Interest Rate - 3.00%
 First Five Year Interest Rate - 4.80%

Minimum Closing Balance in Year 1 :\$120,816
Total Cash Outlay: \$41,602,200
Total Expenditures: \$39,751,867
